Materials and Processes Engineering's Role in the Reconstruction and Failure Analysis of The Space Shuttle Columbia

Rick Russell

NASA Orbiter Project Support Office

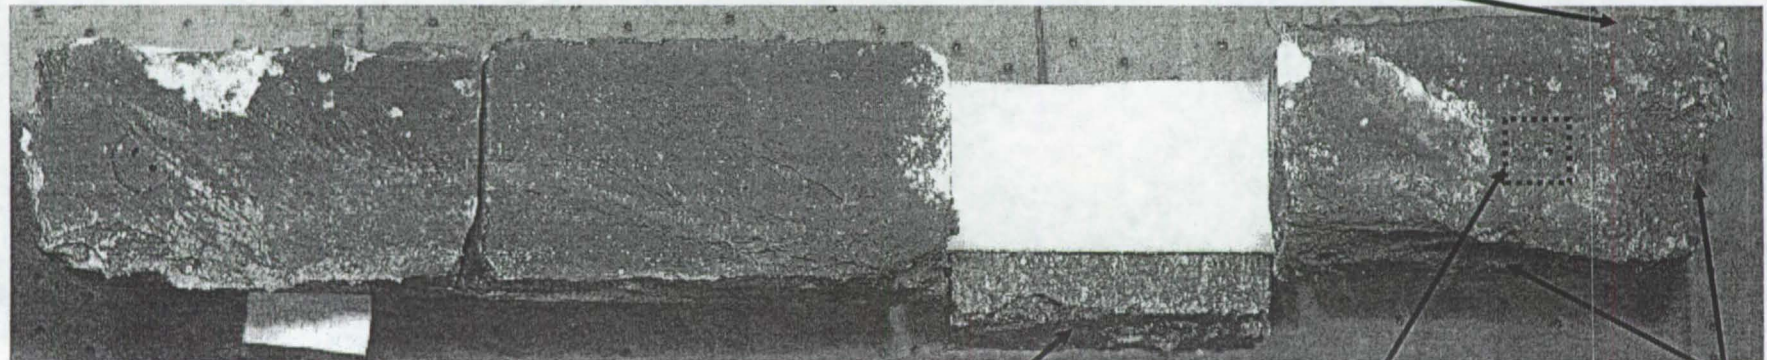
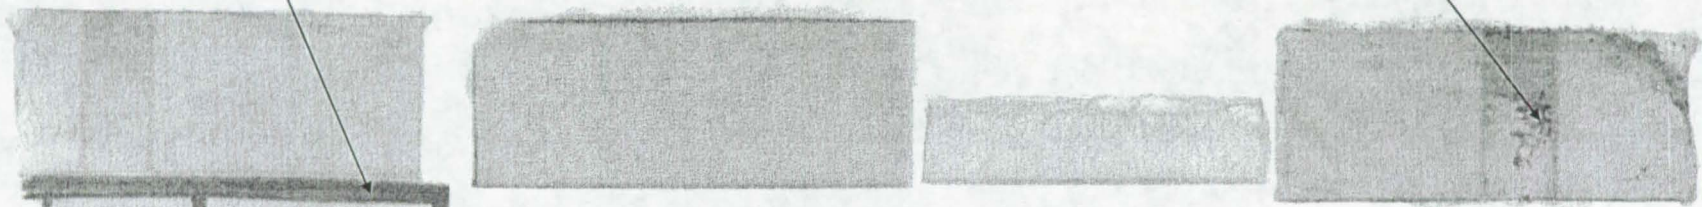
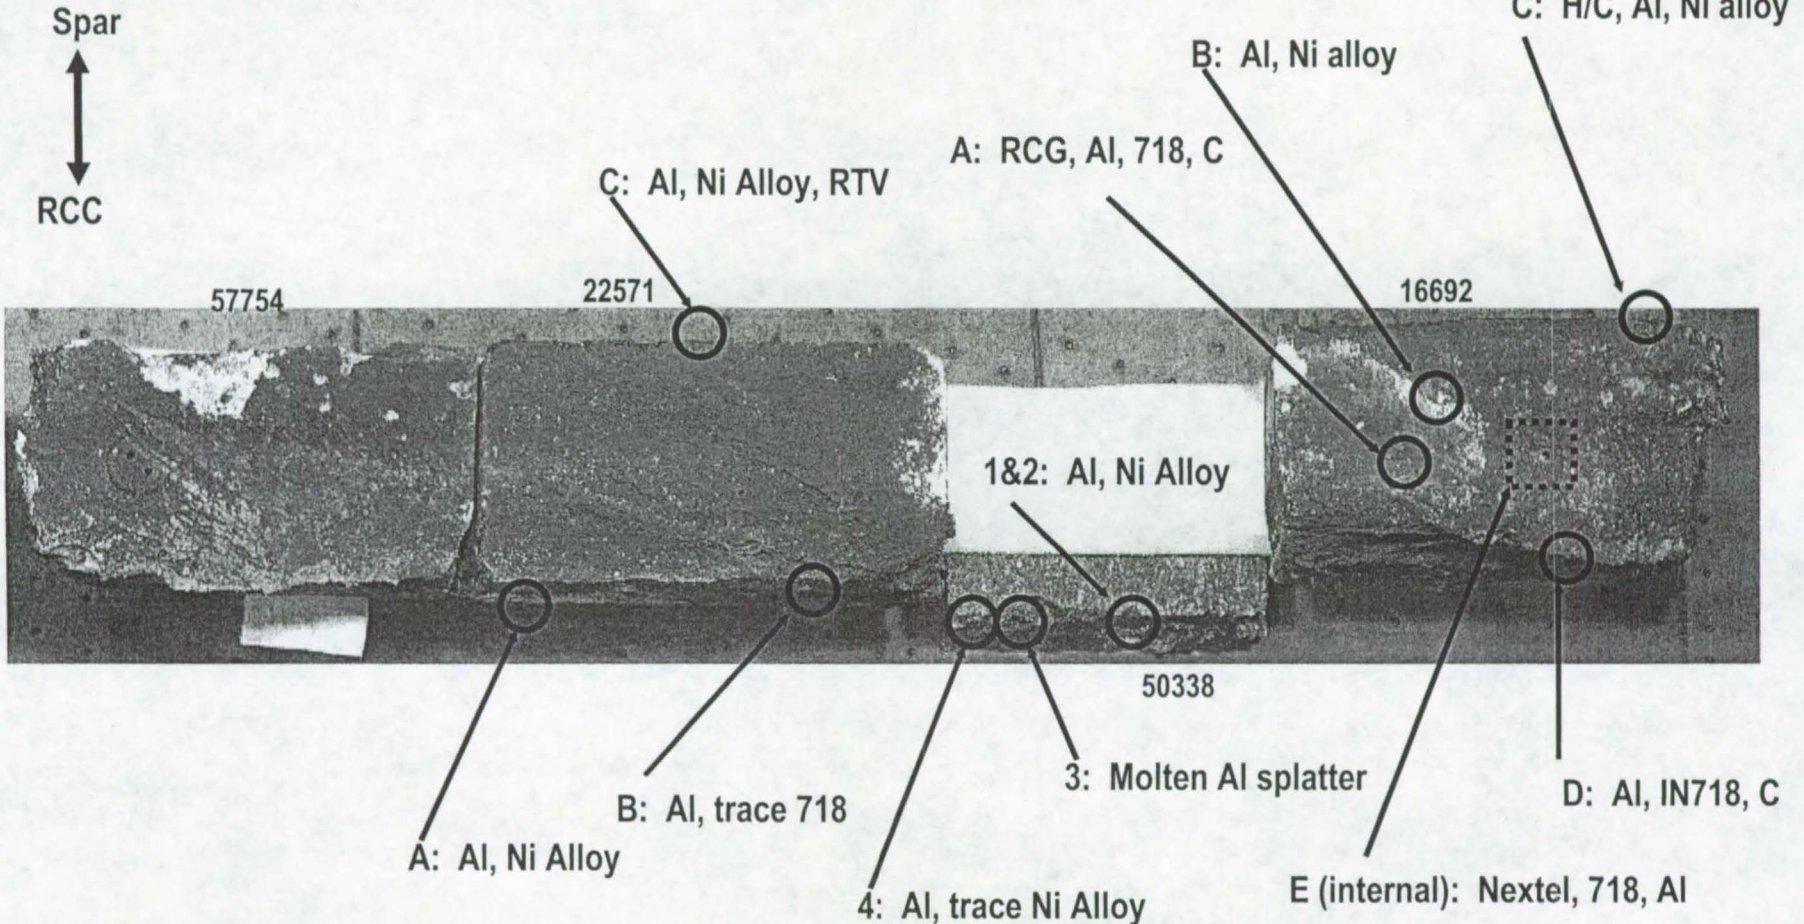
LH RCC Panel 9 Lower CP Tiles

Molten Slag on Tile

Tile Slumping

These findings suggest flow of material from inside the RCC out through the upper and lower CP locations.

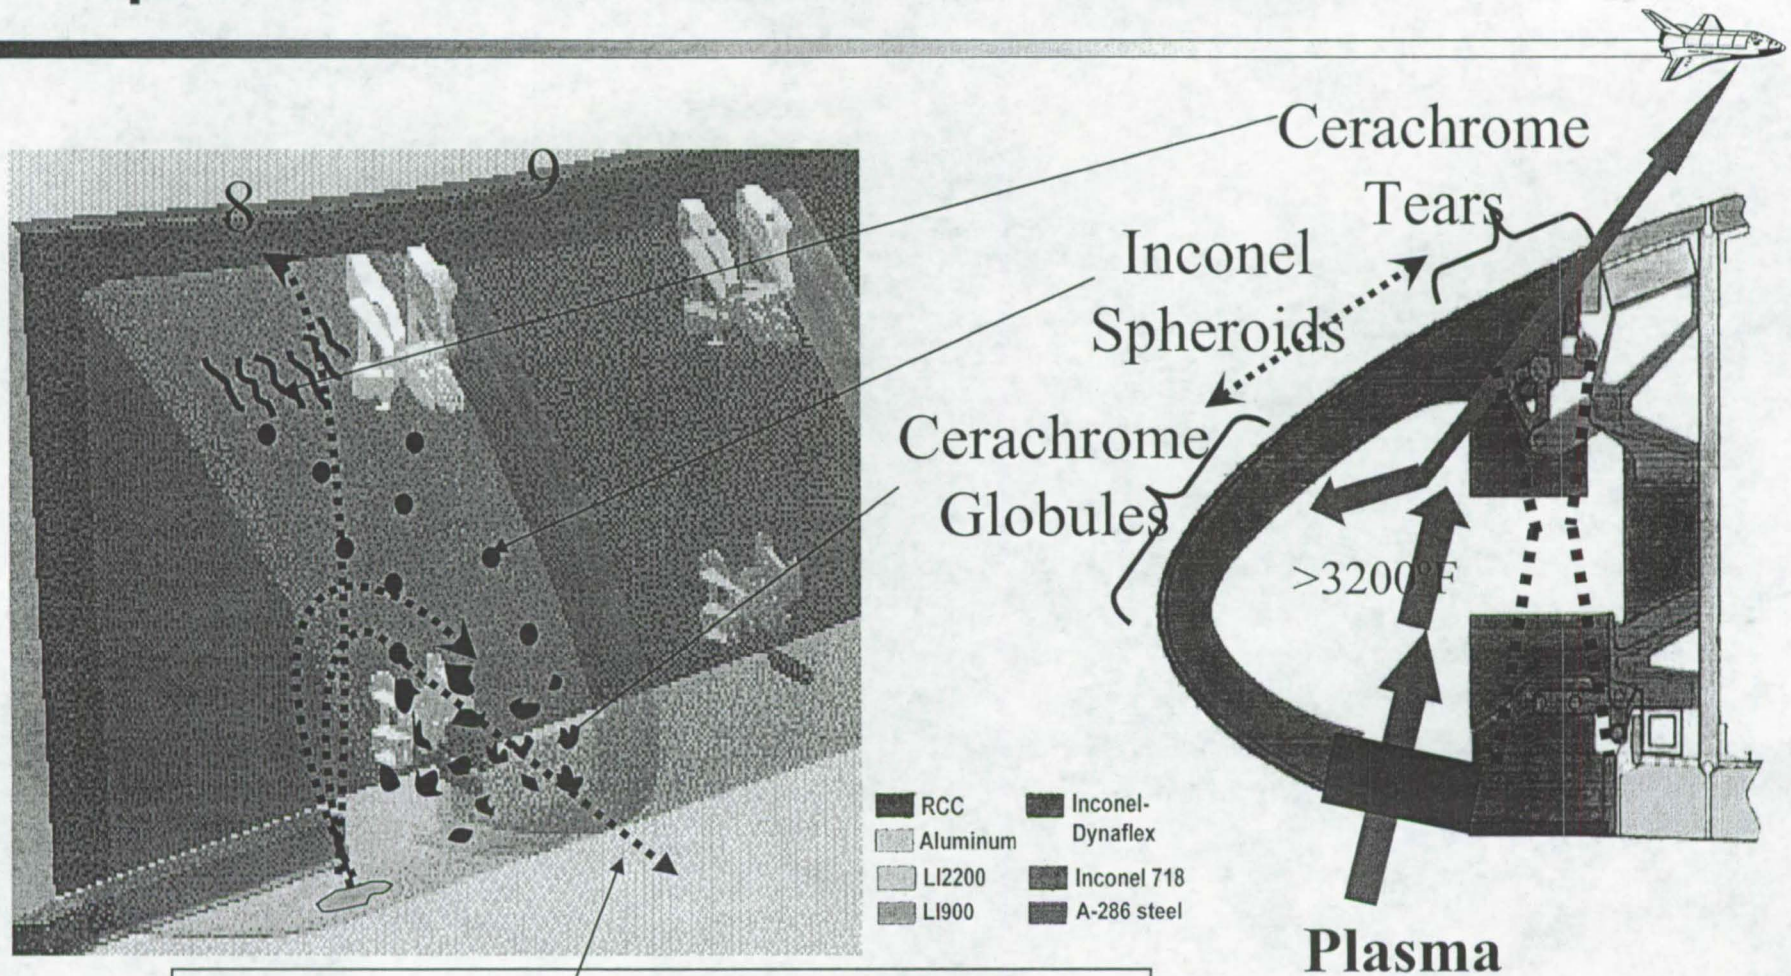
Proposed Breach Location and Plasma Flow

Flow Exiting through RCC 8 on to lower Carrier Panel 9 tiles

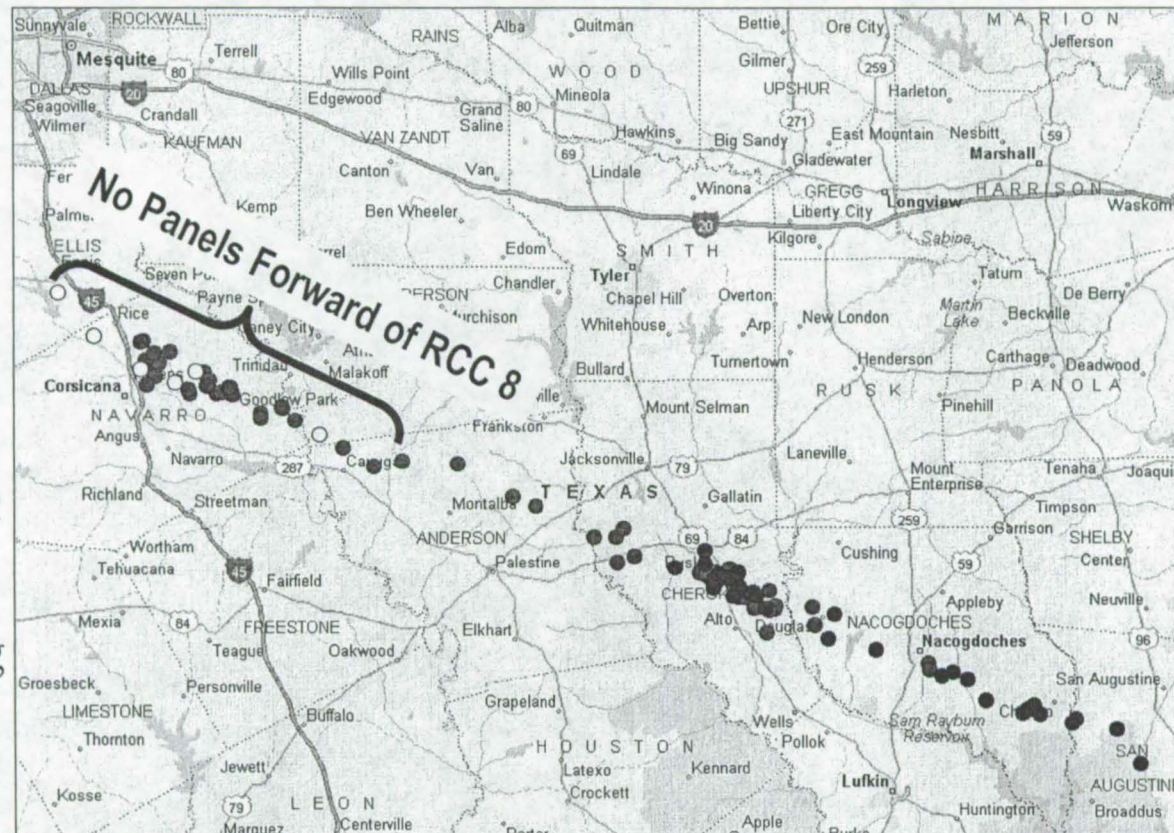
- Panels at RCC 8 and Aft Dropped First
- All Eroded RCC Pieces (in 8 & 9) Found to the West
- R/H Wing Panels and L/H Wing Panels 1-8 Found to the East

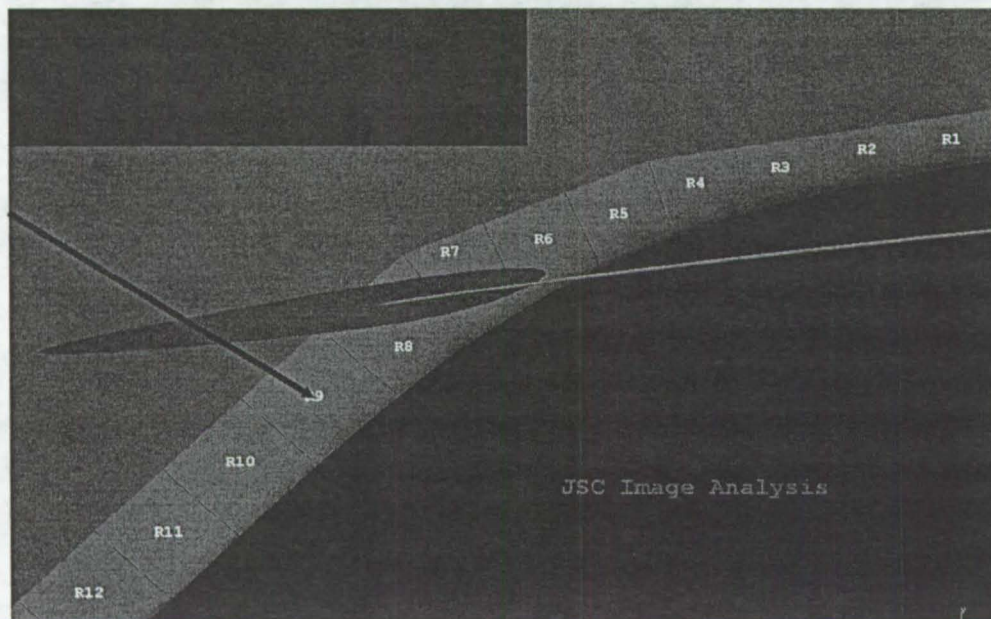
- Trajectory “pipe” of one foot diameter mapped onto the left wing
- Centerline of pipe intersects the wing at approximately RCC panel 8, with most likely foam impact predicted along panels 7 and 8.

Impact Near T-Seal to RCC 8-9 Carrier Panel Joint is a Possibility
